SOCIAL HOUSING BUILDING ENVELOPE RETROFIT IN RUSSIA

NEW MATERIAL ASSEMBLY APPLICATION

A DARCH PROJECT SUBMITTED TO THE GRADUATE DIVISION OF THE
UNIVERSITY OF HAWAI'I AT MĀNOA IN PARTIAL FULFILLMENT OF THE
REQUIREMENTS FOR THE DEGREE OF

DOCTOR OF ARCHITECTURE

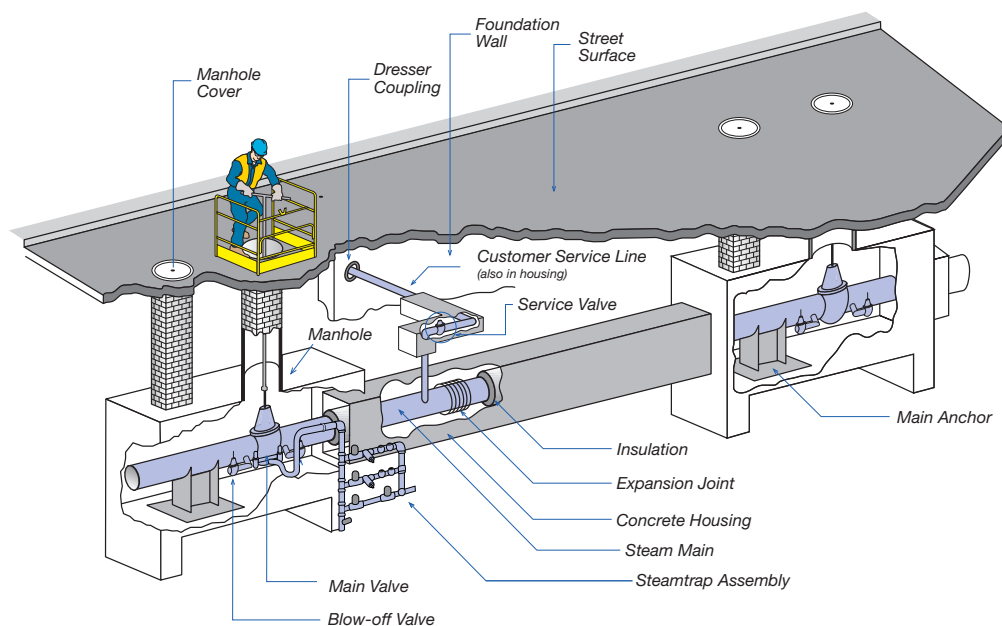
Figure 2.6: Con Edison Steam Distribution Diagram
<http://www.coned.com/>

less expensive to install distribution piping. Steam based piping must be insulated, laid into the “channels and encased in four-foot-by-four-foot concrete jackets, in order to withstand traffic disturbances,”⁴⁷ as the pipes are laid below the streets. New York City’s steam heating system loses a significant amount of energy due to leaks in the system and requires pipes to be updated constantly. Due to the inefficiencies of steam heating many cities in the US are beginning to switch to hot water based heating systems.⁴⁸ Figure 2.6 is a schematic diagram that shows how the New York City steam piping system was built.

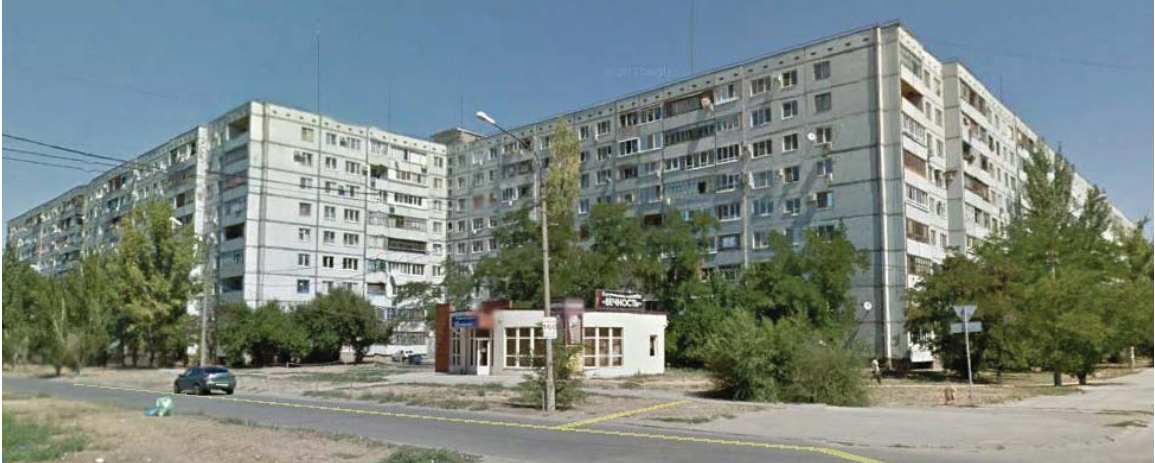
Figure 4.12: Volzhsky, UL, Druzhby 48 (18 M/R-H)

Figure 4.12, 4.13 and Figure 4.14 show the building exterior which is a 9-story standard prefabricated housing structure that was built in the 1960's. While visually, the building appears to be a single structure it actually consists of 13 separate 9-story structures that are built with exterior walls touching each other and sharing a single street address. Each of the 13-9 story structures have 4 units on each floor for a total 468 units. Each of the 13 structures have a separate entry, elevator and central stair

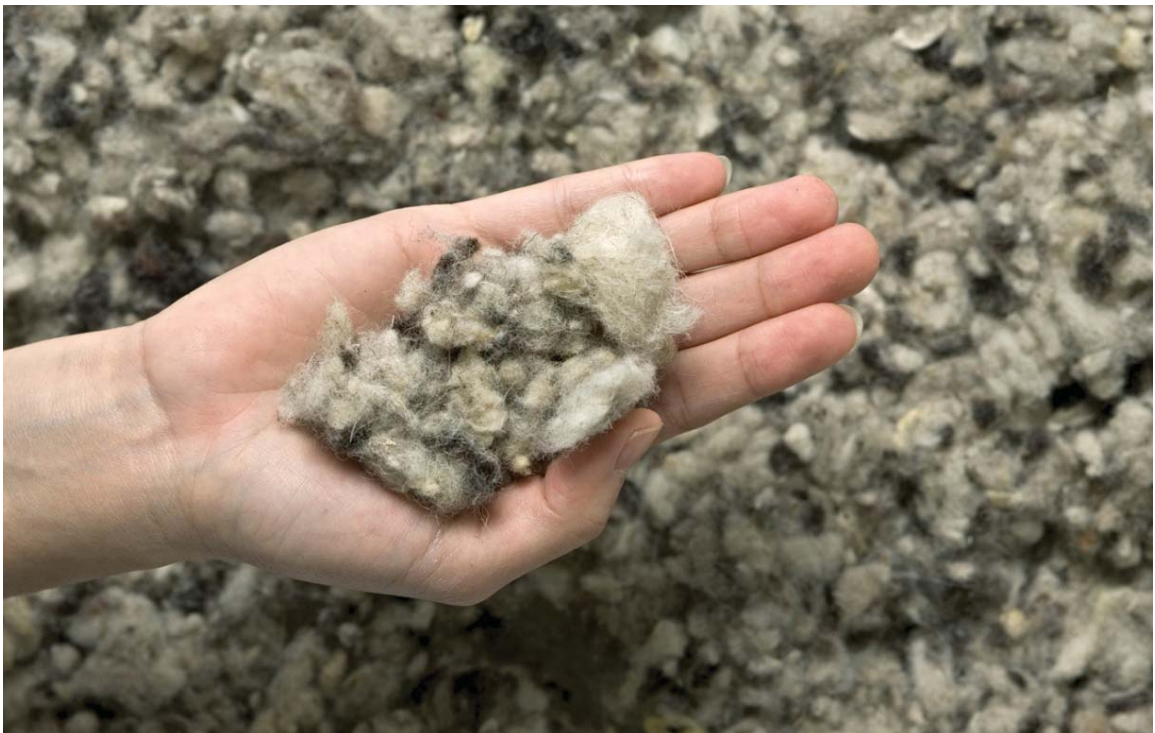
Figure 5.2: Mineral Wool Loose Fill Insulation
<http://becgreen.ca/category/energy-efficiency/insulation/>

25% filler and binding materials. It is incredibly fire resistant. Mineral wool is produced in several forms: a roll or batt form (Figure 5.1), a loose fill form (Figure 5.2) and a rigid board form (Figure 5.3). The first two forms are the most common forms of insulation used worldwide.³

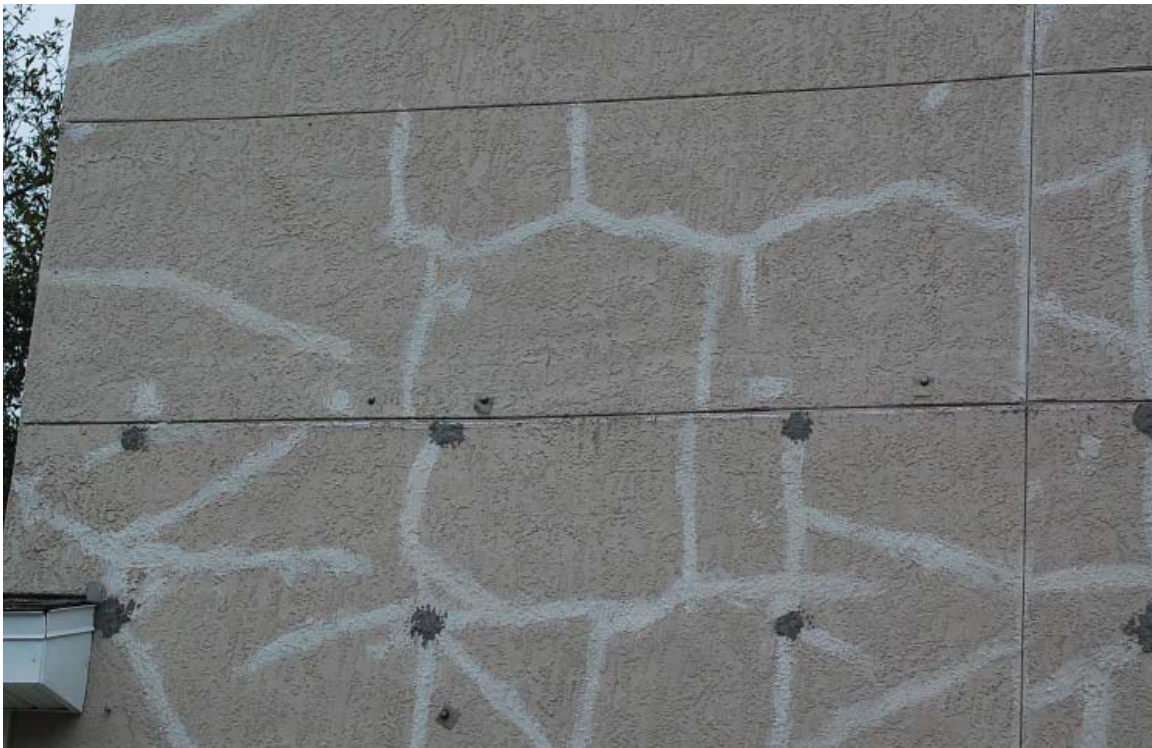
Figure 5.4: Cracking and Repair of Plaster Finish

that the plastering is somewhat labor intensive which can increase the costs of the retrofit. In addition, there are high maintenance requirements of plaster, including the need to repaint and reseal periodically to minimize cracking. Preventing cracking is incredibly important. If the surface cracks, water can penetrate the plaster and then, as it freezes, it will expand and cause the cracking to become exponentially more extensive. Figure 5.4 is an image of a severely cracked plaster wall. Due to the issues with a plaster coat finish, a better alternative would be a prefabricated insulation panel that can be installed easily and used more efficiently. All in all, an exterior cladding system would be a better alternative.

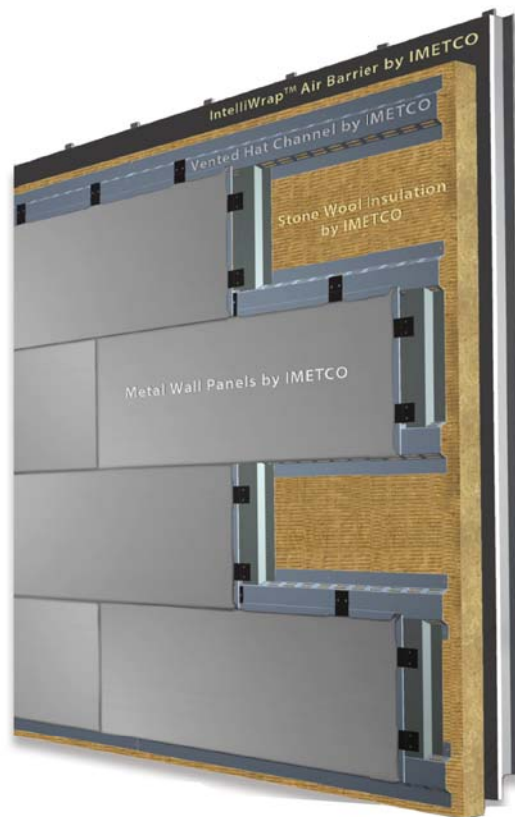
Figure 5.5: IntelliScreen Structural Break Down
http://imetco.com/media/IntelliScreen_Rainscreen_Brochure.pdf

there is a metal wall panel finish that is attached to the sub-grid. These metal panels come in a variety of materials, colors and finishes. The R-Value of this insulation system is based on the mineral wool being used and as such has approximately a 3.7 R-value per inch. A diagram of the IntelliScreen exterior façade system is shown in Figure 5.5 and 5.6.

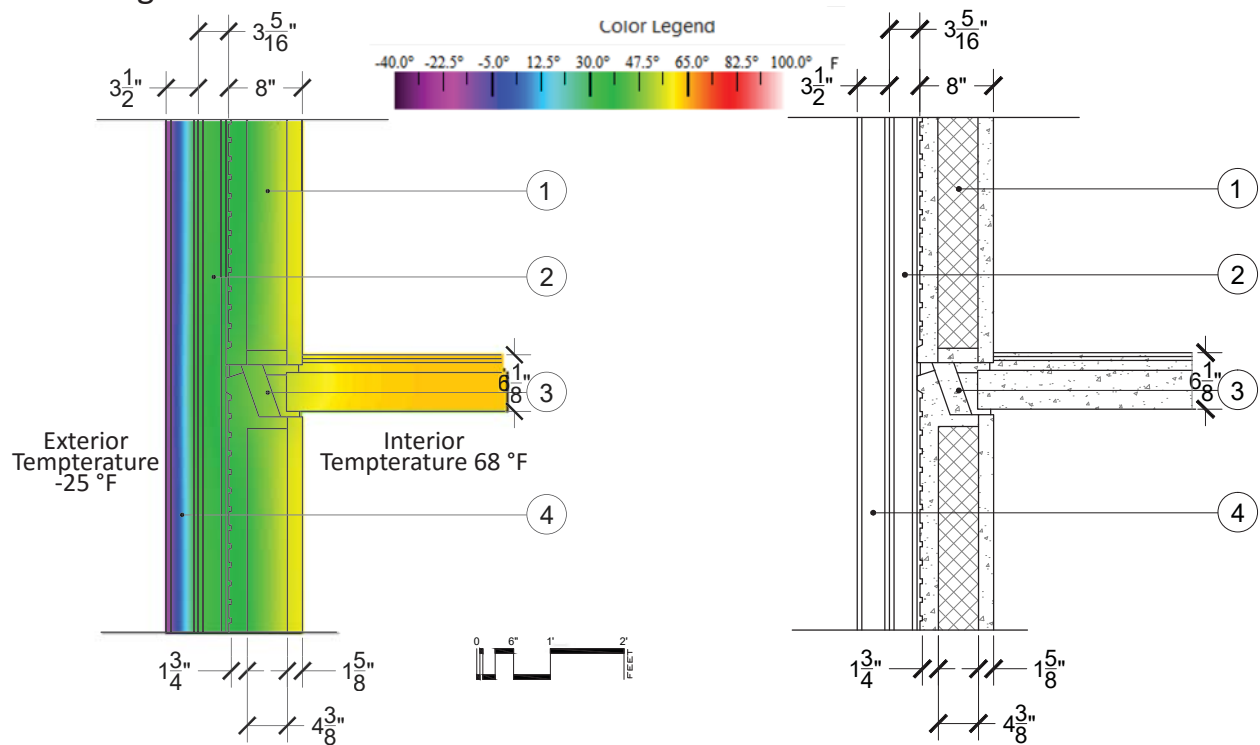
Figure 7.2: Basic Exterior Wall Insulated Prefab Panel Retrofit

1. EXISTING RUSSIAN PREFABRICATED CONCRETE SANDWICH PANEL

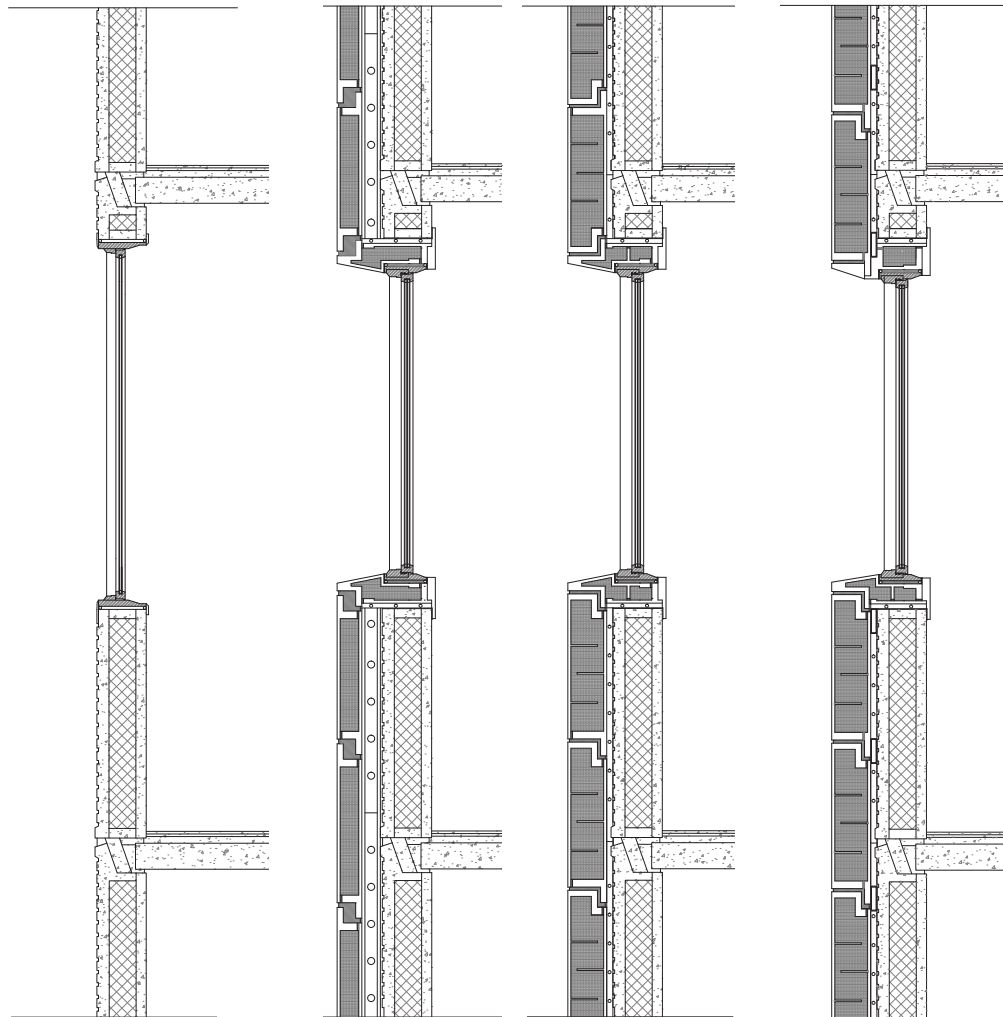
1. RUSSIAN PREFABRICATED CONCRETE S,
2. RUSSIAN PREFABRICATED CONCRETE P,
JOINT CONDITION.
3. RUSSIAN DOUBLE PANE WINDOW (U-VAL

condition which in most apartments may have a sliding glass door as well. For the purposes of testing, only the walls with small windows will be examined as they represent the most consistent exterior condition in most of the panels. This small bedroom window takes up around 28 percent of the total panel area and therefore is a location for substantial heat loss if not accounted for in the calculations. Figure 7.3 shows an entire wall section of one panel that has been examined in the Therm program to establish a baseline.

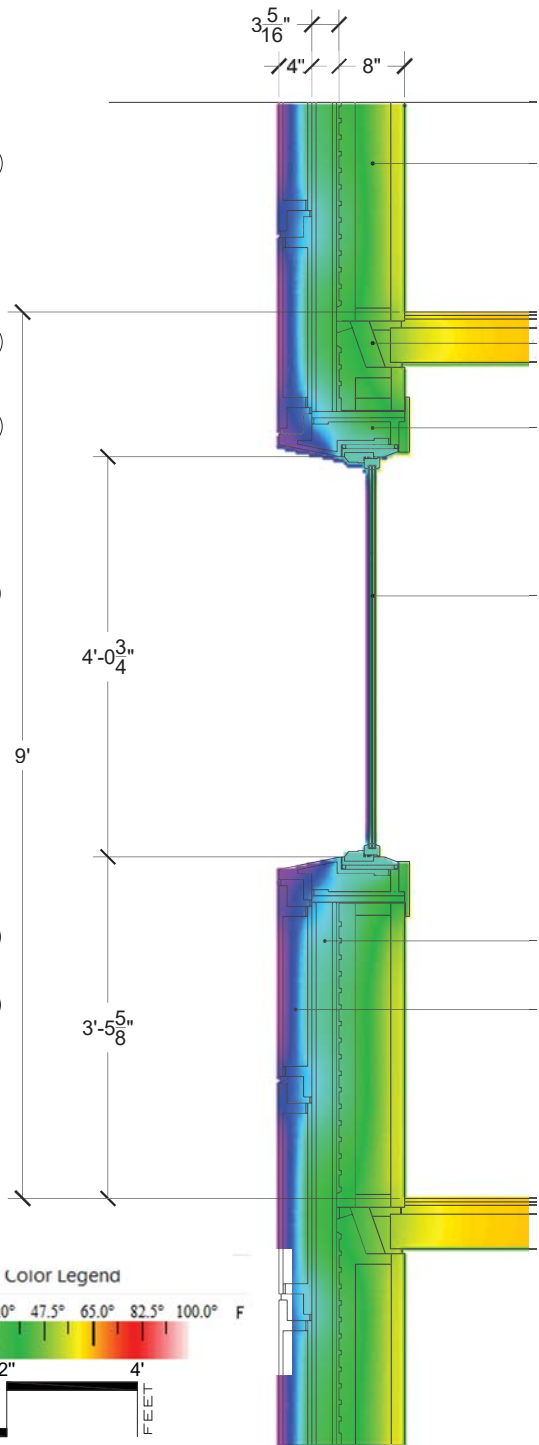
Figure 7.5: Panel R16 (Therm)

1. EXISTING RUSSIAN PREFABRICATED CONCRETE SANDWICH PANEL
2. EXISTING RUSSIAN PREFABRICATED CONCRETE PANEL FLOOR AND JOINT CONDITION.
3. NEW PREFABRICATED FIBER CEMENT WINDOW FRAME
4. NEW TRIPLE PANE, ARGON FILLED, LOW E GLASS OPERABLE WINDOW.
5. NEW PREFABRICATED INSULATED FIBER CEMENT PANELS
6. CELLULOSE INSULATION INTERIOR

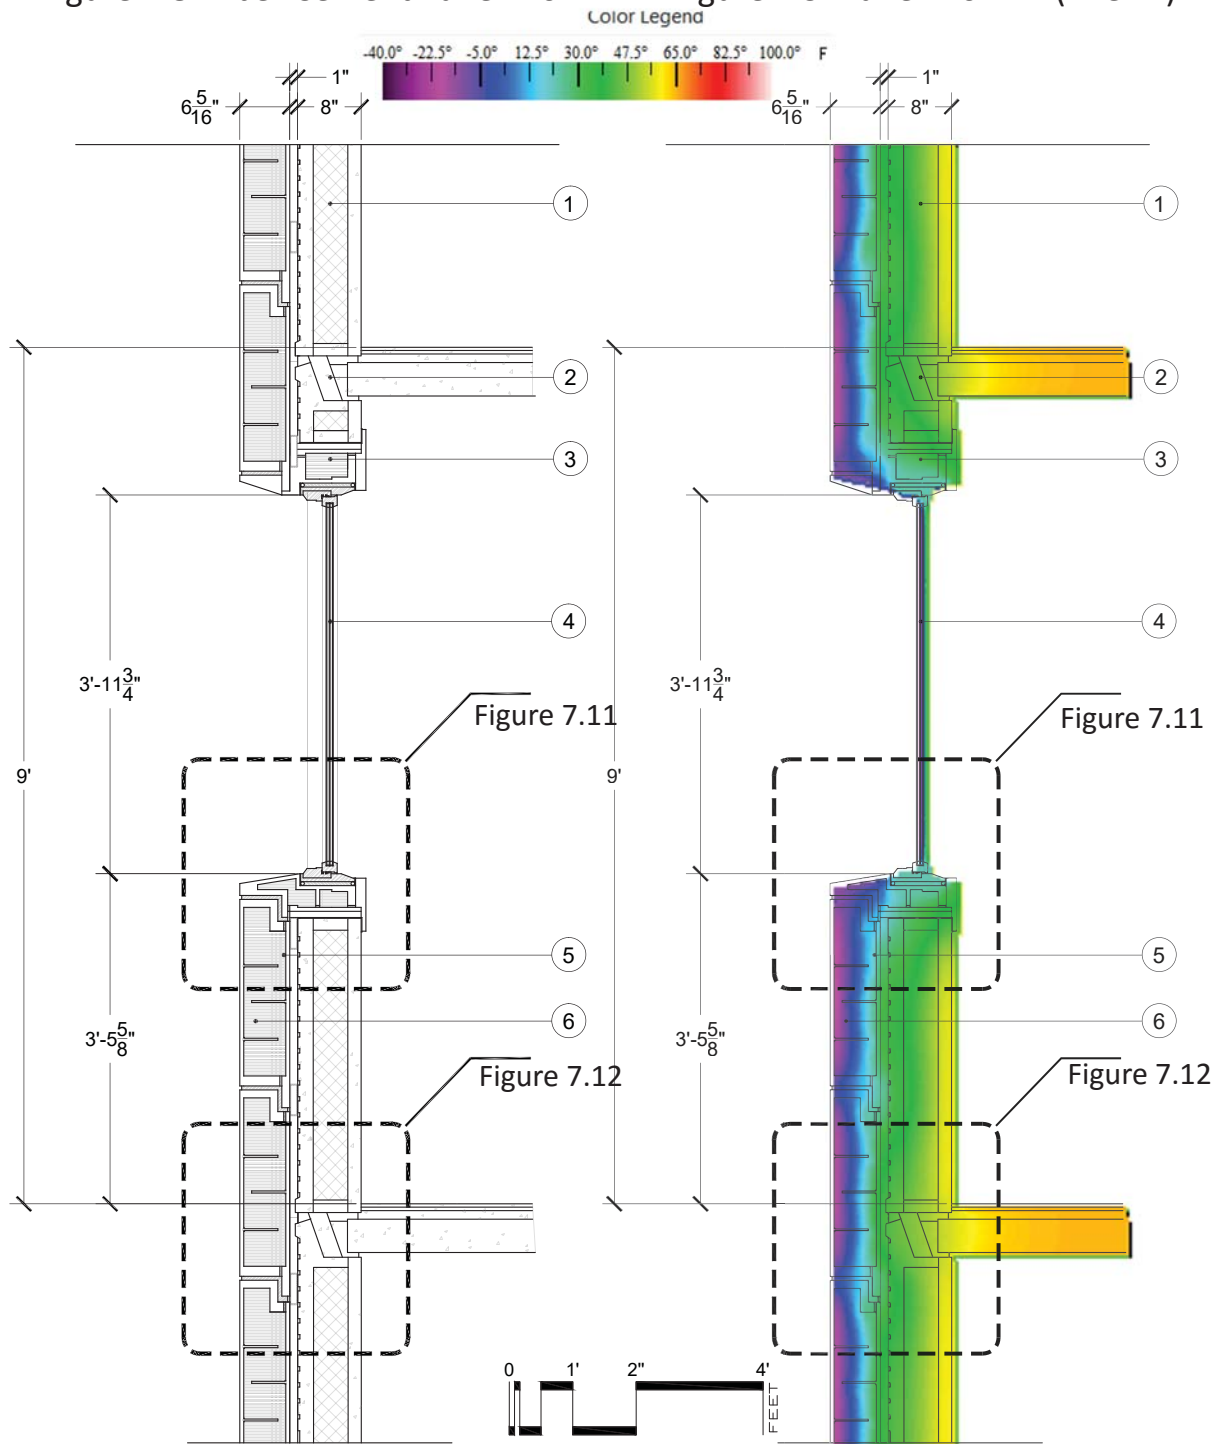
Figure 7.8: Fiber Cement Panel 2.0 **R27** Figure 7.9: Panel 2.0 **R27** (Therm)

1. EXISTING RUSSIAN PREFABRICATED CONCRETE SANDWICH PANEL
2. EXISTING RUSSIAN PREFABRICATED CONCRETE PANEL FLOOR AND JOINT CONDITION.
3. NEW PREFABRICATED FIBER CEMENT WINDOW FRAME
4. NEW TRIPLE PANE, ARGON FILLED, LOW E GLASS OPERABLE WINDOW.
5. NEW PREFABRICATED INSULATED FIBER CEMENT PANELS
6. CELLULOSE INSULATION INTERIOR

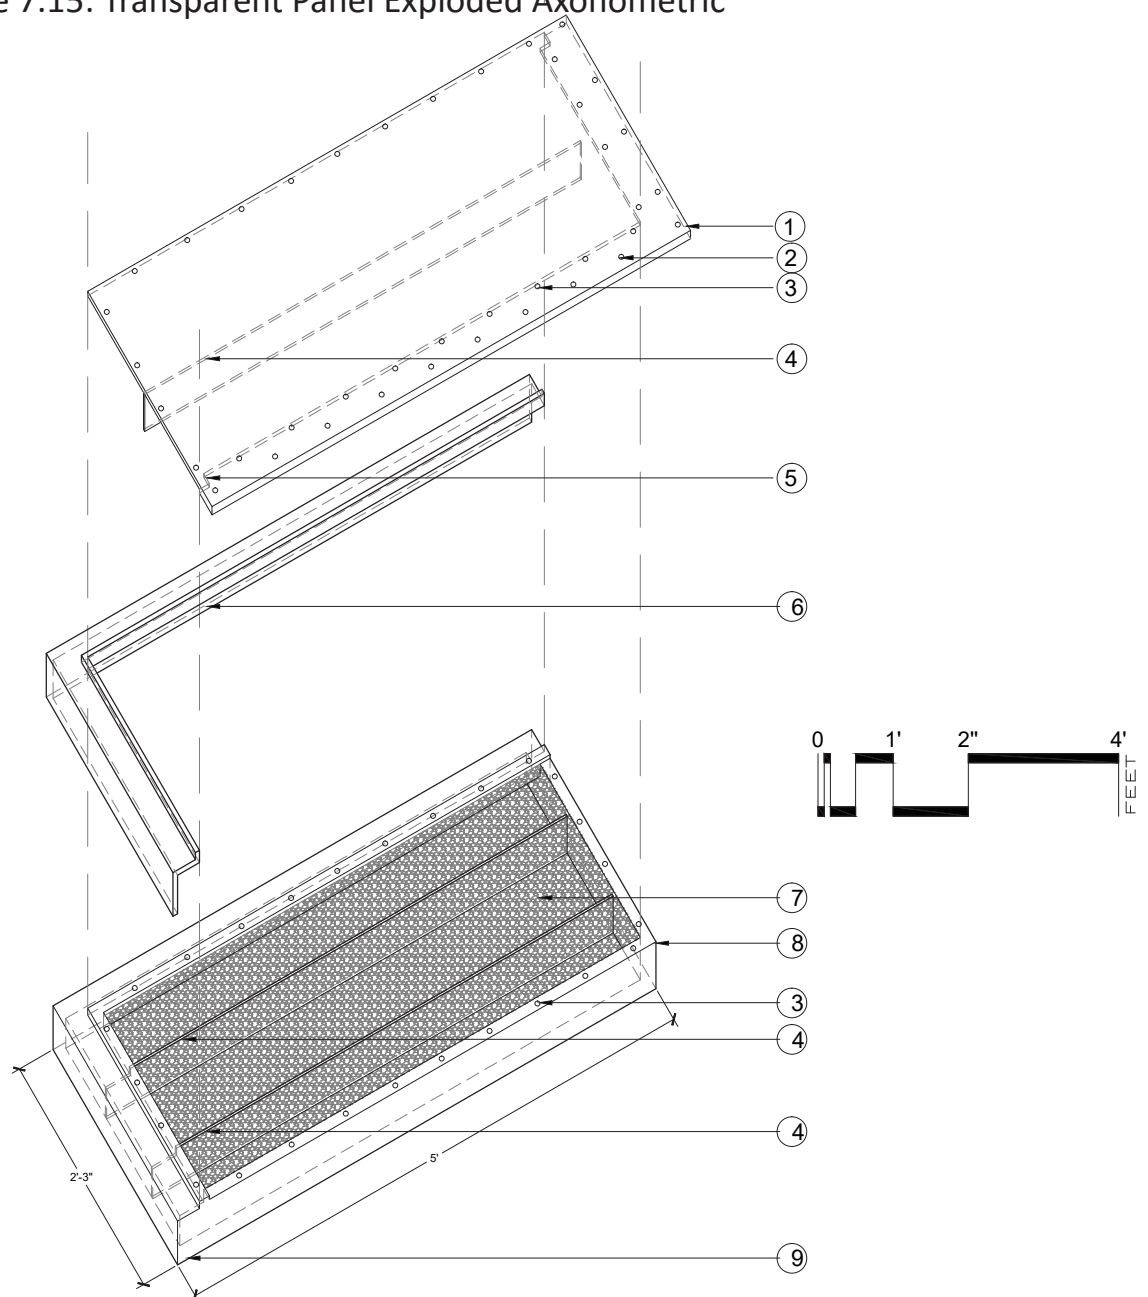
Figure 7.15: Transparent Panel Exploded Axonometric

1. BACKSIDE OF PREFABRICATED FIBER CEMENT PANEL
2. BOLT LOCATIONS TO FASTEN PANEL TO ALUMINUM FRAME ON THE EXTERIOR OF THE BUILDING
3. BOLT LOCATIONS THAT FASTEN THE TWO PIECES OF THE PANEL TOGETHER WITH URETHANE THERMAL BREAK AT THE CONNECTION INTERIOR HIGH DENSITY URETHANE FIN FOR INTERIOR STABILITY
4. FIBER CEMENT FIN TO STABILIZE THE INTERIOR OF THE PANEL
5. 1/2" JOINT STEP DOWN
6. URETHANE CLOSED CELL FOAM CONNECTION PAD BETWEEN PANELS FOR WATER PROOFING, MINIMIZING THERMAL BRIDGES AT CONNECTIONS AND IMPROVED INSULATION AT THE JOINT CONDITION
7. CELLULOSE INSULATION WET APPLIED
8. EXTERIOR PREFABRICATED FIBER CEMENT PANEL WITH INTERIOR FLUID APPLIED WATER PROOFING COATING TO MAKE WATER TIGHT.
9. FACE OF EXTERIOR PREFABRICATED FIBER CEMENT PANEL (MANY FORMS, FINISH OR COLORS)

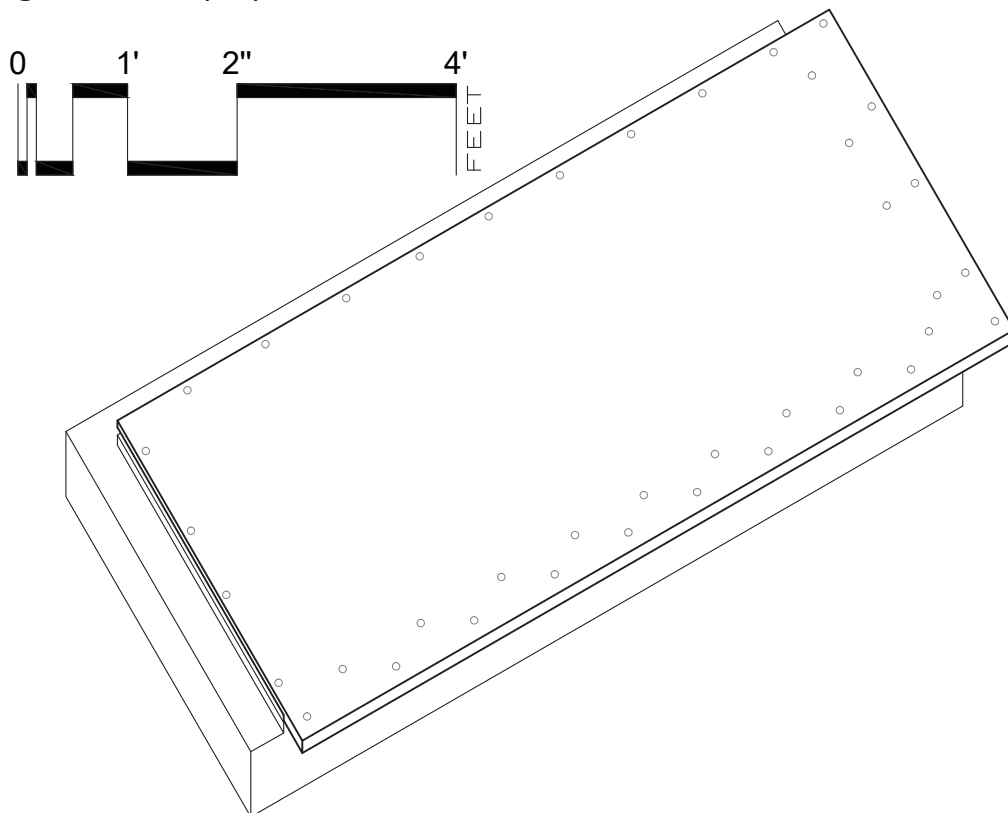
Figure 7.17: Opaque Panel Axonometric

cement finish in a charcoal color.

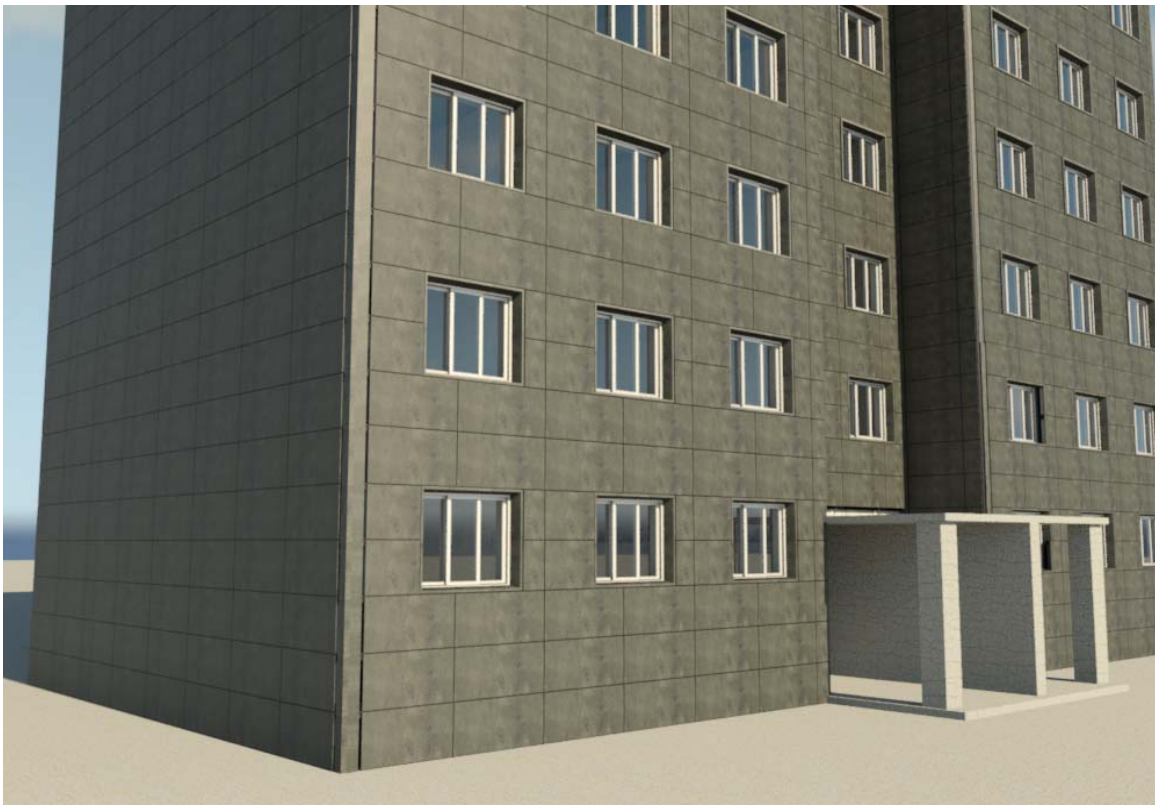
Figure 7.19: New Facade on 9-Story Building Typology

Now that an alternative material system has been designed that improves upon VTT Technical's design and satisfies all the criteria for thermal improvement, the next step is to apply this new exterior insulation system to the exterior of the selected social housing apartment building in Volzhsky. Due to the repetitive nature of the building design, applying this new insulation panel to just one 9-story 4 unit floor plan building at Volzhsky, UL, Druzhby 48 (18 M/R-N) is all that is necessary to show façade application. Modeled in Figure 7.18, is the original unaltered building façade prior to adding the new material. Figure 7.19, shows what the building would look like with just the basic fiber

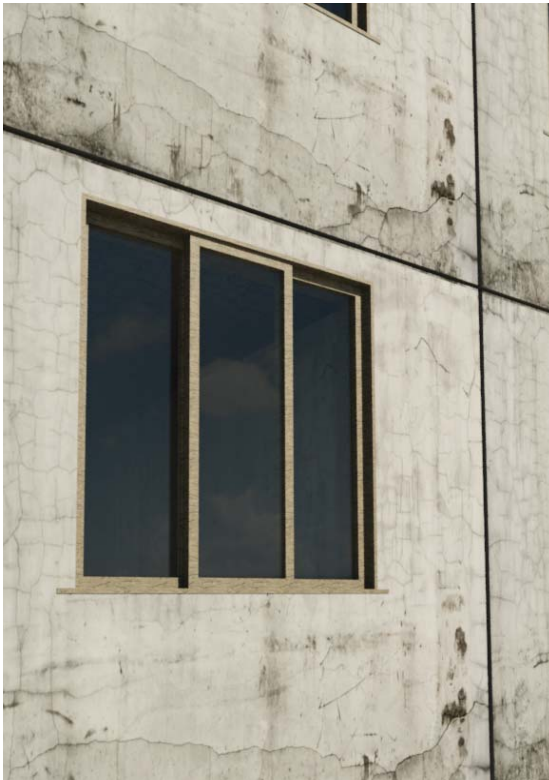
Figure 7.21: Unaltered Window Area

These finishes could all be applied to the exterior of this new fiber cement panel and could be modified or combined to create new finish variations. Figures 7.21 and 7.22 show a close up of the building and new fiber cement panel options with a window condition. Figures 7.23 and Figure 7.24 demonstrate possible variations by altering the exterior finish of the panel to something that resembles stone during the manufacturing process. The new material is not only compositionally a better alternative to the VTT Technical's recommendation of mineral wool and plaster coat finish, but it also is very aesthetically appealing and creates the ability to mass produce a building exterior that can have different façade finishes allowing for these buildings to be more unique and appear less repetitive.

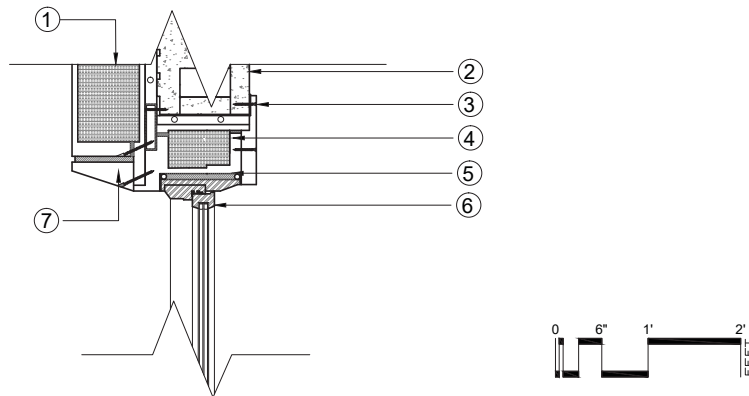
1. NEW PREFABRICATED FIBER CEMENT PANEL WITH CELLULOSE INSULATION
2. EXISTING RUSSIAN WALL PANEL
3. INTERIOR PREFABRICATED FIBER CEMENT WINDOW TRIM FASTENED TO NEW PREFABRICATED FIBER CEMENT INSULATED WINDOW PANEL FRAME WITH $\frac{1}{4}$ " SCREWS
4. MANUFACTURE ASSEMBLED PREFABRICATED FIBER CEMENT WINDOW SILL AND FRAME WITH PRE-INSTALLED WINDOW.
5. SILICONE SPACERS ON BED OF SILICONE
6. MANUFACTURE INSTALLED SLIDING INTERIOR WINDOW FRAME
7. NEW WINDOW HEAD END CAP SECURED TO PREFABRICATED WINDOW AFTER INSTALLATION WITH $\frac{1}{4}$ " SCREW IN PREDRILLED HOLE. FILL DRILL HOLE WITH SILICONE SEALANT MATCHING FIBER CEMENT COLOR

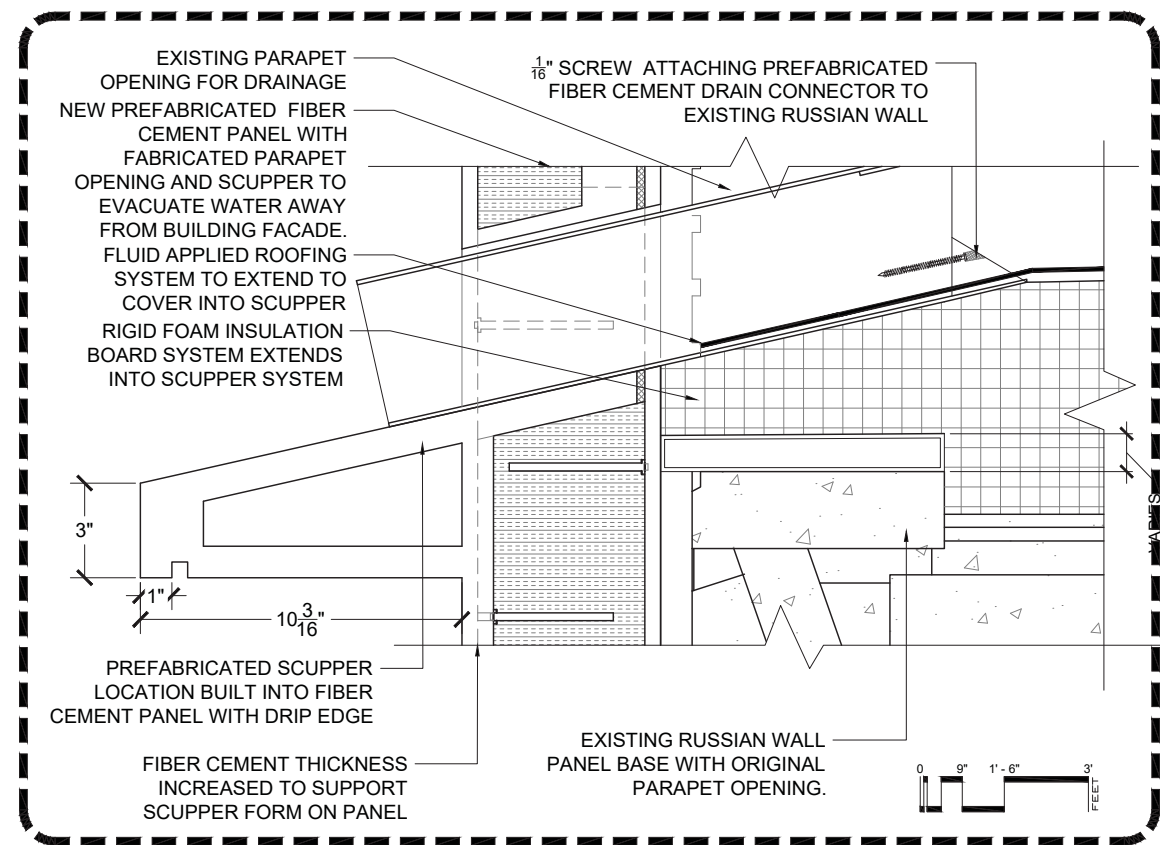
Figure 8.37: Panel Footing Wall Section Therm

implementation of them in the field. Due to the complicated nature of installing the panel system on the roof, as well as the increased weight of the panels for a thicker, denser version of fiber/micro rebar cement. The overall cost savings of using the panel in a roof application is minimized, and a more traditional roof insulation system is recommended.

existing footing of the building as shown in the footing wall detail in Figure 8.38. In the event that the footing needs to be strengthened then the footing can be strengthened first and then the prefabricated base panel can be placed on top of the footing and then secured against the wall. A couple feet above ground, the footing panel will terminate and the sub-grid system will secure to this panel thereby taking the majority of the vertical load of the new panels. The remainder of the load will be carried by the existing structure, through the existing walls down to the foundation. When the new fiber cement panels are attached to the walls, a base cap will be placed at the bottom completing the base connection of the panel to the prefabricated footing. This is shown in Figure 8.39.

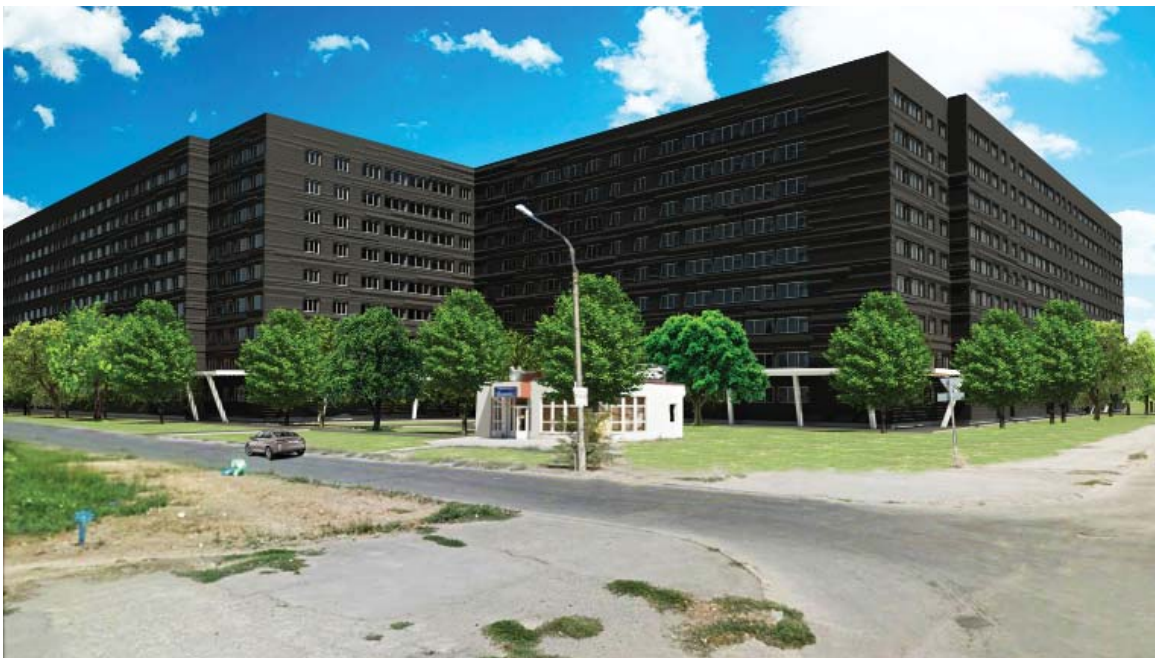
Figure 9.5: Site Location After Renovation

In Figures 9.4 and 9.5, you can see before and after renderings of the building design. The new panels are a dark charcoal grey which creates a strong contrast with the surrounding environment. In addition, this design will have better heat gain during the winter months making the panels more effective at retaining heat on the interior of the spaces. Figure 9.6 shows the lighting effect of the building at night with an awning system that lights up to provide light for the walkways below and creates drama with the angled panels at night as well as during the day. Figure 9.7 is an original basic finish design, while Figure 9.8 shows the angled panel design that was incorporated in the design in Volzhsky. In addition, Figures 9.9 and 9.10 show the walkway area with the trellis system overhead.

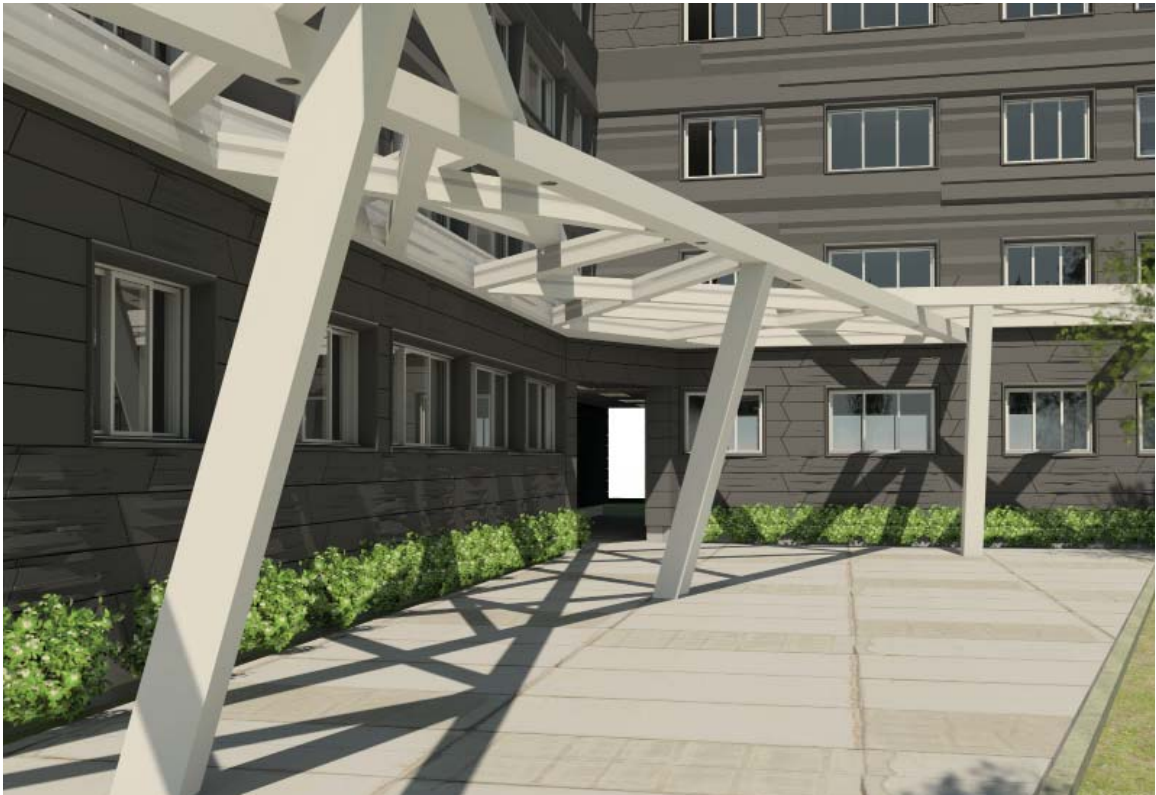
Figure 9.9: Exterior Walkway Rendering

Because the building is so large, there are periodic pass-through points that occur in the building where the first floor unit is not built and instead a covered walkway through the building is in its place, allowing for people to get from the street side to the courtyard side of the building. This allows them to enter their perspective units once in the interior courtyard area. The new design incorporates a formal entry point as well as highlights the other entry points along the building façade through which people can enter the interior courtyard area. The entry was placed in the 90 degree angle created by the two sides of buildings L-shaped wings. In order to direct pedestrian traffic flow to this location, a very dramatic awning system was created that would shade the sidewalk below from and while at the same time create a dramatic focal point of the building that directs people through the building and into the interior of the space. The awning itself is an aluminum triangular shaped trellis. They comprised of overlapping triangular angles that create a dramatic shadow effect on the walkway below.

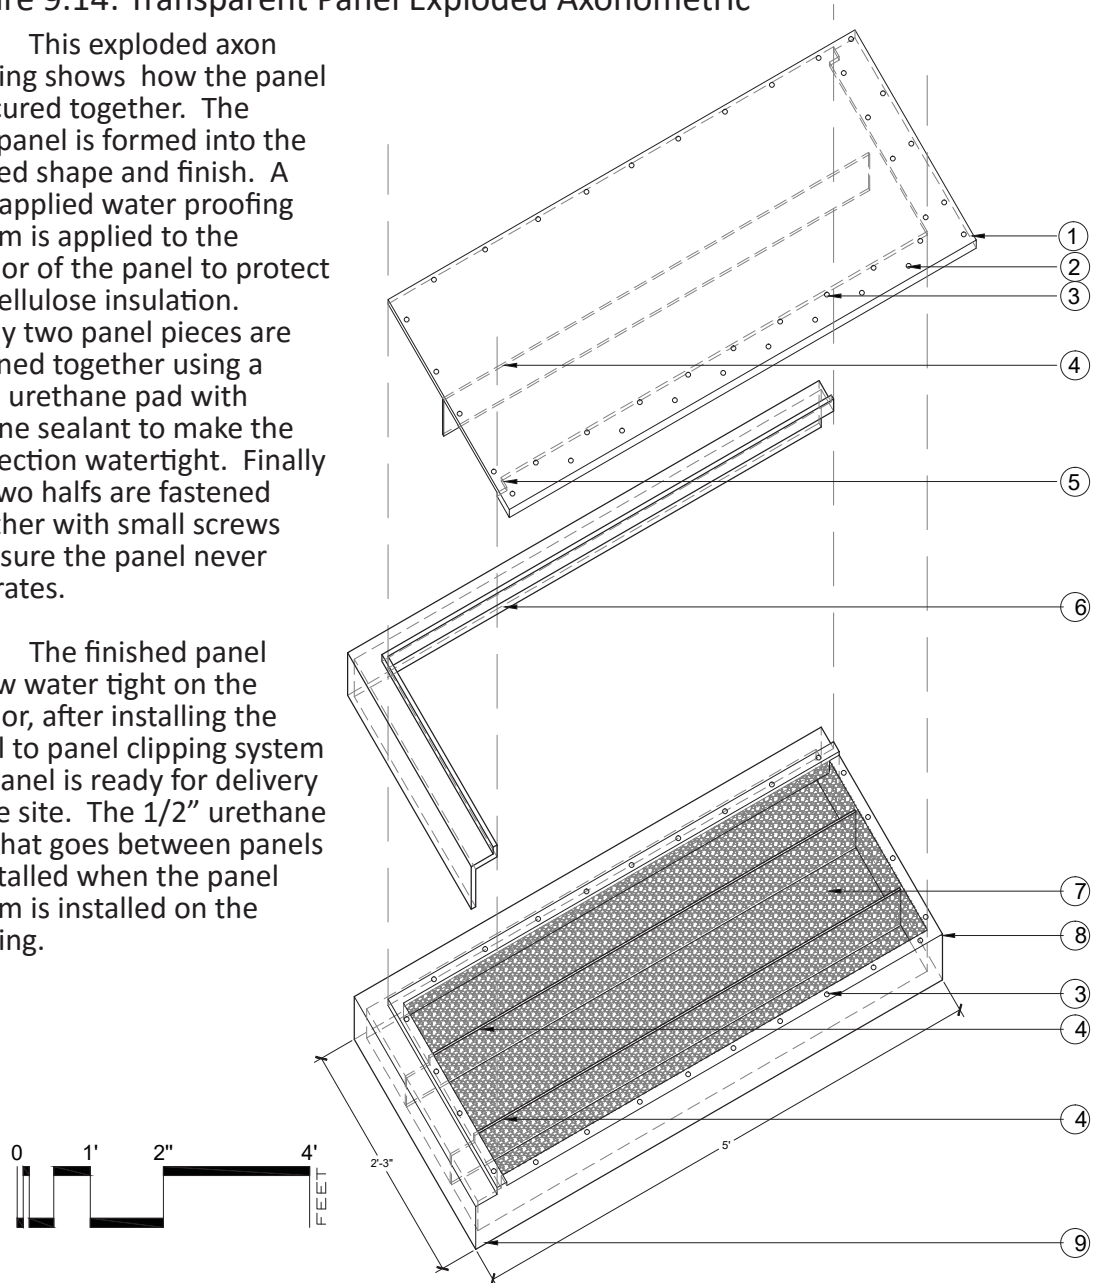
1. BACKSIDE OF PREFABRICATED FIBER CEMENT PANEL
2. BOLT LOCATIONS TO FASTEN PANEL TO ALUMINUM FRAME ON THE EXTERIOR OF THE BUILDING
3. BOLT LOCATIONS THAT FASTEN THE TWO PIECES OF THE PANEL TOGETHER WITH URETHANE THERMAL BREAK AT THE CONNECTION INTERIOR HIGH DENSITY URETHANE FIN FOR INTERIOR STABILITY
4. FIBER CEMENT FIN TO STABILIZE THE INTERIOR OF THE PANEL
5. 1/2" JOINT STEP DOWN
6. URETHANE CLOSED CELL FOAM CONNECTION PAD BETWEEN PANELS FOR WATER PROOFING, MINIMIZING THERMAL BRIDGES AT CONNECTIONS AND IMPROVED INSULATION AT THE JOINT CONDITION
7. CELLULOSE INSULATION WET APPLIED
8. EXTERIOR PREFABRICATED FIBER CEMENT PANEL WITH INTERIOR FLUID APPLIED WATER PROOFING COATING TO MAKE WATER TIGHT.
9. FACE OF EXTERIOR PREFABRICATED FIBER CEMENT PANEL (MANY FORMS, FINISH OR COLORS)

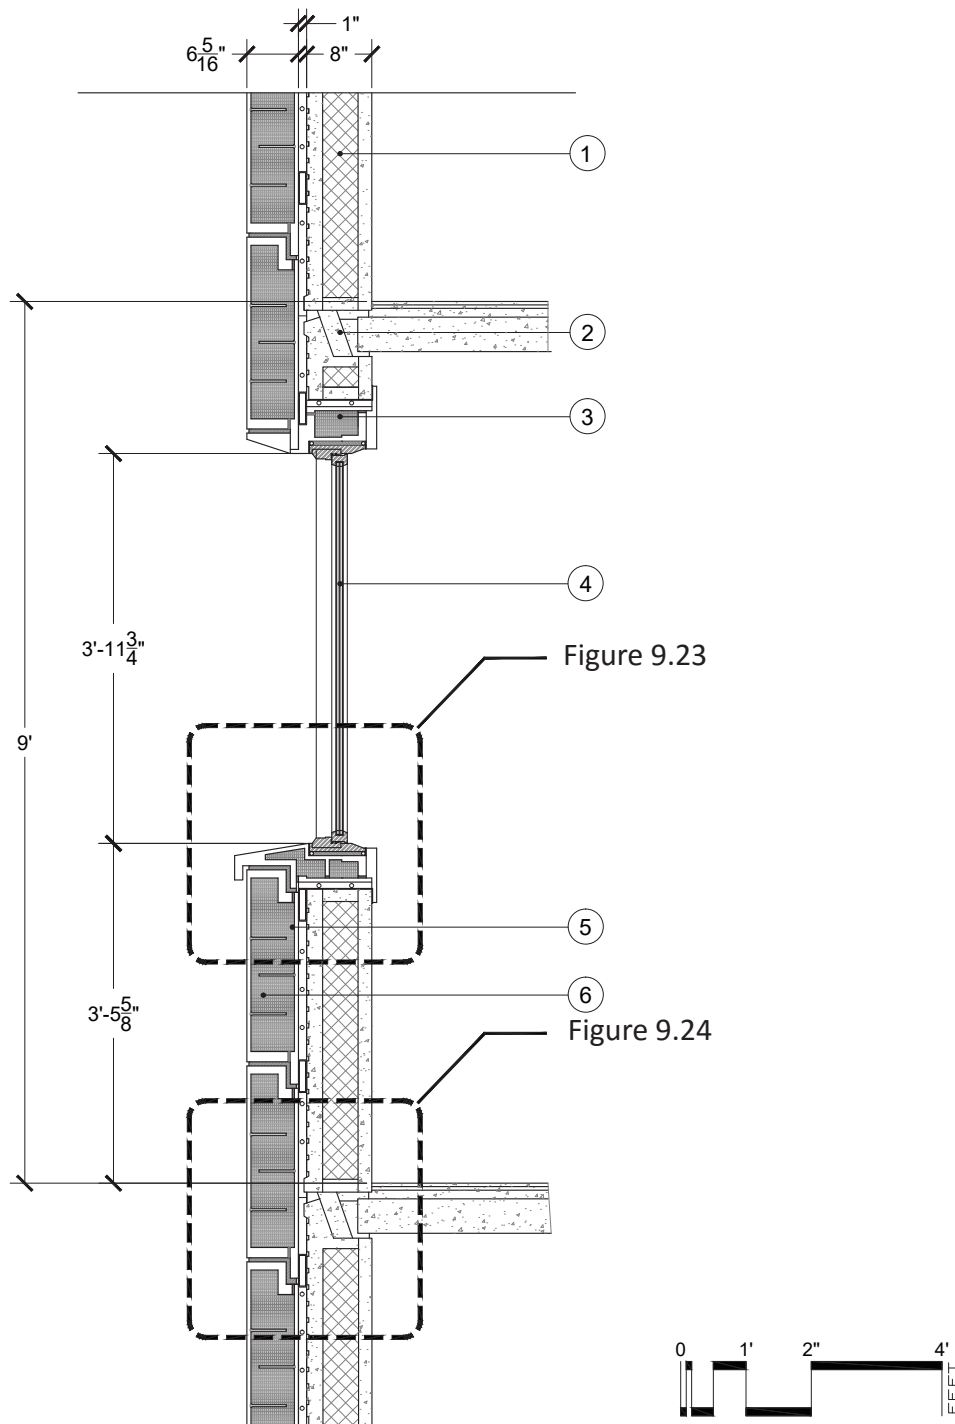
1. EXISTING RUSSIAN PREFABRICATED CONCRETE SANDWICH PANEL
2. EXISTING RUSSIAN PREFABRICATED CONCRETE PANEL FLOOR AND JOINT CONDITION.
3. NEW PREFABRICATED FIBER CEMENT WINDOW FRAME
4. NEW TRIPLE PANE, ARGON FILLED, LOW E GLASS OPERABLE WINDOW.
5. NEW PREFABRICATED INSULATED FIBER CEMENT PANELS
6. CELLULOSE INSULATION INTERIOR

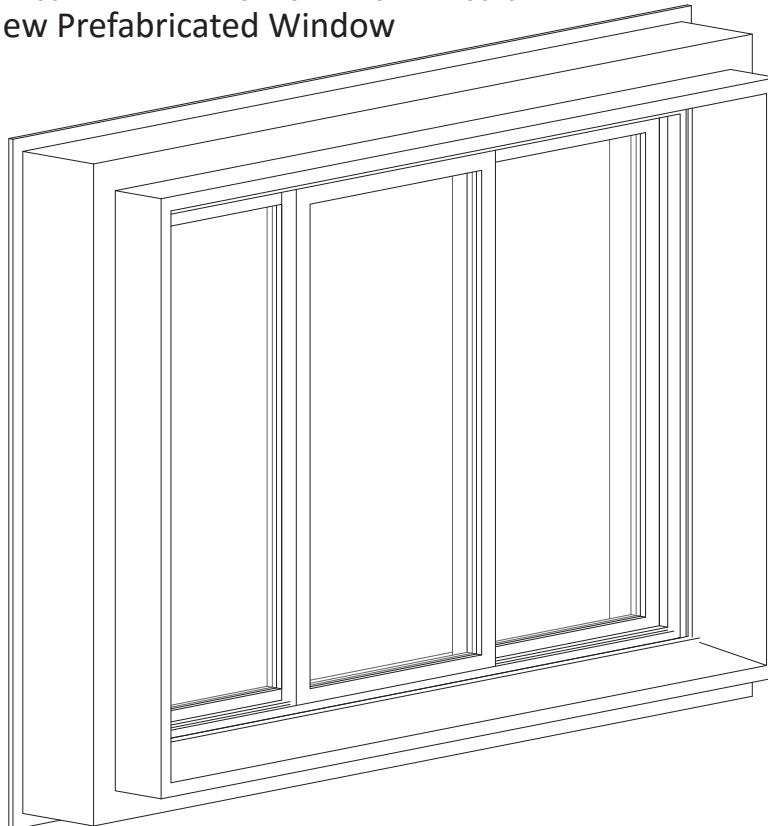
Figure 9.33: New Prefabricated Window

1. NEW PREFABRICATED FIBER CEMENT PANEL WITH CELLULOSE INSULATION
2. EXISTING RUSSIAN WALL PANEL
3. INTERIOR PREFABRICATED FIBER CEMENT WINDOW TRIM FASTENED TO NEW PREFABRICATED FIBER CEMENT INSULATED WINDOW PANEL FRAME WITH $\frac{1}{4}$ " SCREWS
4. MANUFACTURE ASSEMBLED PREFABRICATED FIBER CEMENT WINDOW SILL AND FRAME WITH PRE-INSTALLED WINDOW.
5. SILICONE SPACERS ON BED OF SILICONE
6. MANUFACTURE INSTALLED SLIDING INTERIOR WINDOW FRAME
7. NEW WINDOW HEAD END CAP SECURED TO PREFABRICATED WINDOW AFTER INSTALLATION WITH $\frac{1}{4}$ " SCREW IN PREDRILLED HOLE. FILL DRILL HOLE WITH SILICONE SEALANT MATCHING FIBER CEMENT COLOR
